# Laser-induced defects in optical multilayer coatings by the spatial resolved method

The spatial resolved method, which measures the laser-induced damage fluence by identifying the location of the damage point in the Gaussian beam three-dimensional direction, is demonstrated. The advantages and practicality of this method have been explained. Taking a triple frequency beam splitter as an example, the defect damage fluence can be accurately calculated by the spatial resolved method. The different defect damage performance of the triple frequency splitter is distinguished under irradiations of only the 355 and 532 nm lasers. The spatial resolved method provides a way to obtain precise information of optical film defect information.

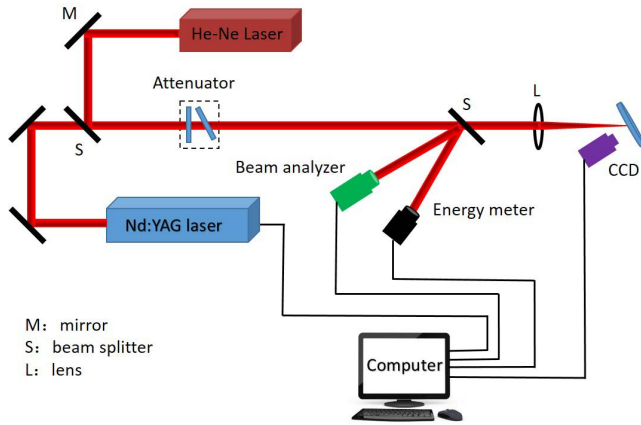
Fig. 1. Schematic diagram of spatial resolved damage testing system.

The schematic diagram of the spatial resolved test system is shown in Fig. 1. The Gaussian laser is obliquely incident on the surface of the test sample with an angle of  $45^\circ$  after the attenuation system, and the focal length of the lens is 5 m. The coordinate of laser damage is observed by a CCD camera with a pixel size of  $1920 \times 1078$  placed after irradiation.

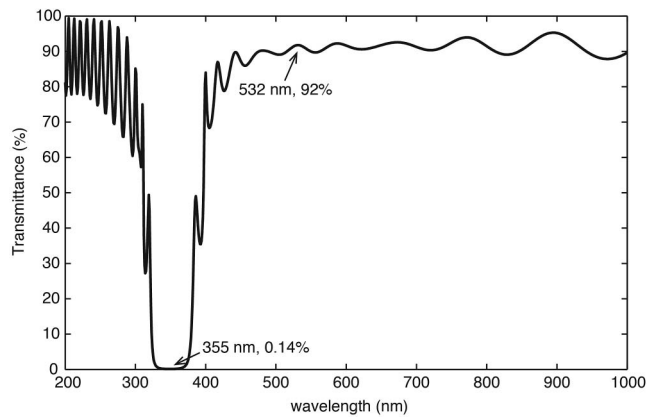
Fig. 4. Transmittance spectrum of the multilayer coating prepared via reactive e-beam evaporation.

at an incident angle of  $45^\circ$  with a wavelength range of 200–1200 nm. The transmittance for 532 nm was 92%, whereas that for 355 nm was 0.14%, as shown in Fig. 4.

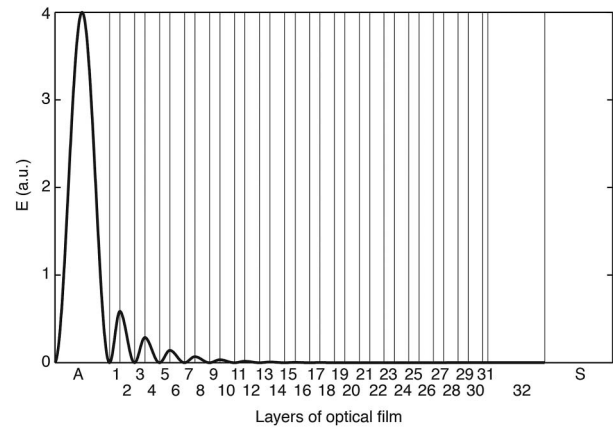
Fig. 6. Electric field of the triple frequency splitter by the 355 nm laser.

Since the peak electric field was mainly distributed on the surface of the optical film (as shown in Fig. 6), in the experiment, the defect damage irradiated by the 355 nm laser was caused by the defect absorbing amount of laser energy under the high electric field, mainly in the first eight layers of the film.

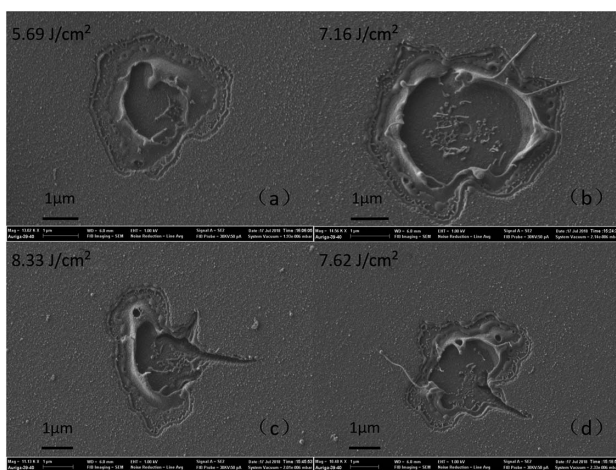
Fig. 5. SEM images of defect damages: class A was irradiated by the 355 nm laser with fluence of (a)  $5.69 \text{ J/cm}^2$  and (b)  $7.16 \text{ J/cm}^2$ , respectively; class B was irradiated by the 355 nm laser with the fluence of (c)  $8.33 \text{ J/cm}^2$  and (d)  $7.62 \text{ J/cm}^2$ , respectively.

Class A defect damage was an independent circular laser damage morphology without any additional defect damage. There were 86 class A defect damages with random distribution in the Gaussian beam. Class B defect damage morphology was a circular damage accompanied by a deep crack damage. There were 46 class B defect damages distributed at the center of the Gaussian beam.

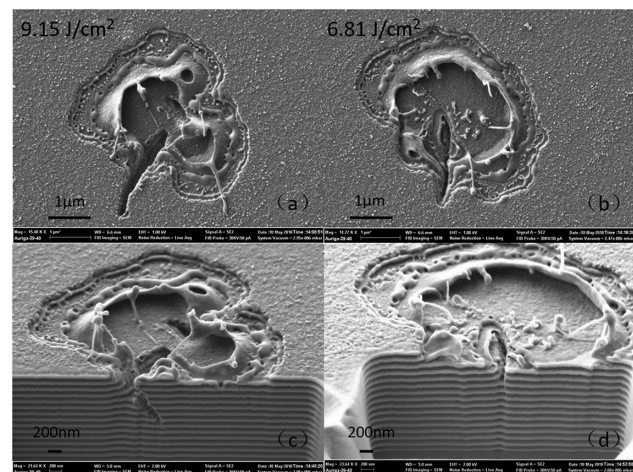
Fig. 7. (a), (b) SEM images and (c), (d) FIB images: class B defect damage morphology of the triple frequency splitter by the 355 nm laser irradiation with the fluence of (a)  $9.15 \text{ J/cm}^2$  and (b)  $6.81 \text{ J/cm}^2$ , respectively; (c) and (d) recorded depth information of class B defect damage morphology.

pit defects existing on the surface of the substrate. Some research groups have done much work on this kind of laser damage morphology and mechanism<sup>[27,28]</sup>. The crack defect in the optical film was caused by scratches or pit defects after e-beam deposition on the surface of the substrate. According to the thermal transfer theory, a phenomenological model is proposed to describe the formation of this damage. At the beginning, the defect absorbed the laser energy under the high electric field in the first eight layers of the optical film. As a result, there was an extremely unstable and high-temperature melting point at the initial position of the defect damage, and the melting point became a new source of crack damage. The range of the damage was increased by the expanding plasma scald in the  $x$ - $y$  and  $z$  directions. The class B defect damage was formed when the plasma penetrated into the crack defect in the  $z$  direction in the optical film (as shown in Fig. 7). Therefore, the initial damage of the class B defect should

be caused by the defects in the first eight layers of the optical film, and the electric field normalization was based on the initial defect damage position in the  $z$  direction in the optical film.

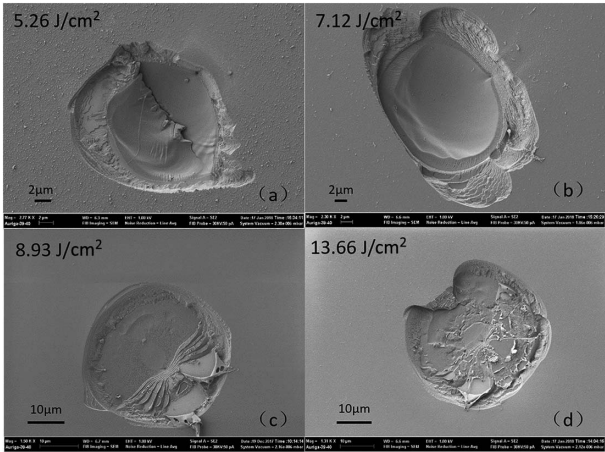
Fig. 8. SEM images of defect damages: class A was irradiated by the 532 nm laser with the fluence of (a)  $5.26 \text{ J/cm}^2$  and (b)  $7.12 \text{ J/cm}^2$ , respectively; class B was irradiated by the 355 nm laser with the fluence of (c)  $8.93 \text{ J/cm}^2$  and (d)  $13.66 \text{ J/cm}^2$ , respectively.

There were also two kinds of defect damage morphologies, class C and class D. The class C defect damage morphologies are shown in Figs. 8(a) and 8(b). The size

of these defect damages was between 12 and  $24 \mu\text{m}$ . Class C was caused by submicron defects on the surface of the substrate. There were 74 class C defect damages, and these defect damages were distributed randomly in the profile of the incident Gaussian beam.

The second kind of defect damage morphology was shown in Figs. 8(c) and 8(d). The size of the class D defect damages was between 35 and  $45 \mu\text{m}$ . Class D defect damage was mainly caused by micron-scale defects existing on the surface of the substrate. There were 45 class D defect damages in our experiments. This type of defect damage was mainly distributed in the center of the Gaussian beam. Finally, the laser damage thresholds of the two kinds of defects were shown in Table 2 by the one-on-one and spatial resolved test methods. The defects break through the film stress, spraying out and causing the damage by absorbing the laser energy. Therefore, the larger the area of defect damage, the greater the film stress that needs to be broken, and the more laser energy needs to be absorbed. It is reasonable that the defect damage threshold of class D is higher than that of class C.
